Special Report 79-12

May 1979

100-70031
FREEZING PROBLEMS ASSOCIATED WITH
SPRAY IRRIGATION OF WASTEWATER
DURING THE WINTER

John R. Bouzoun

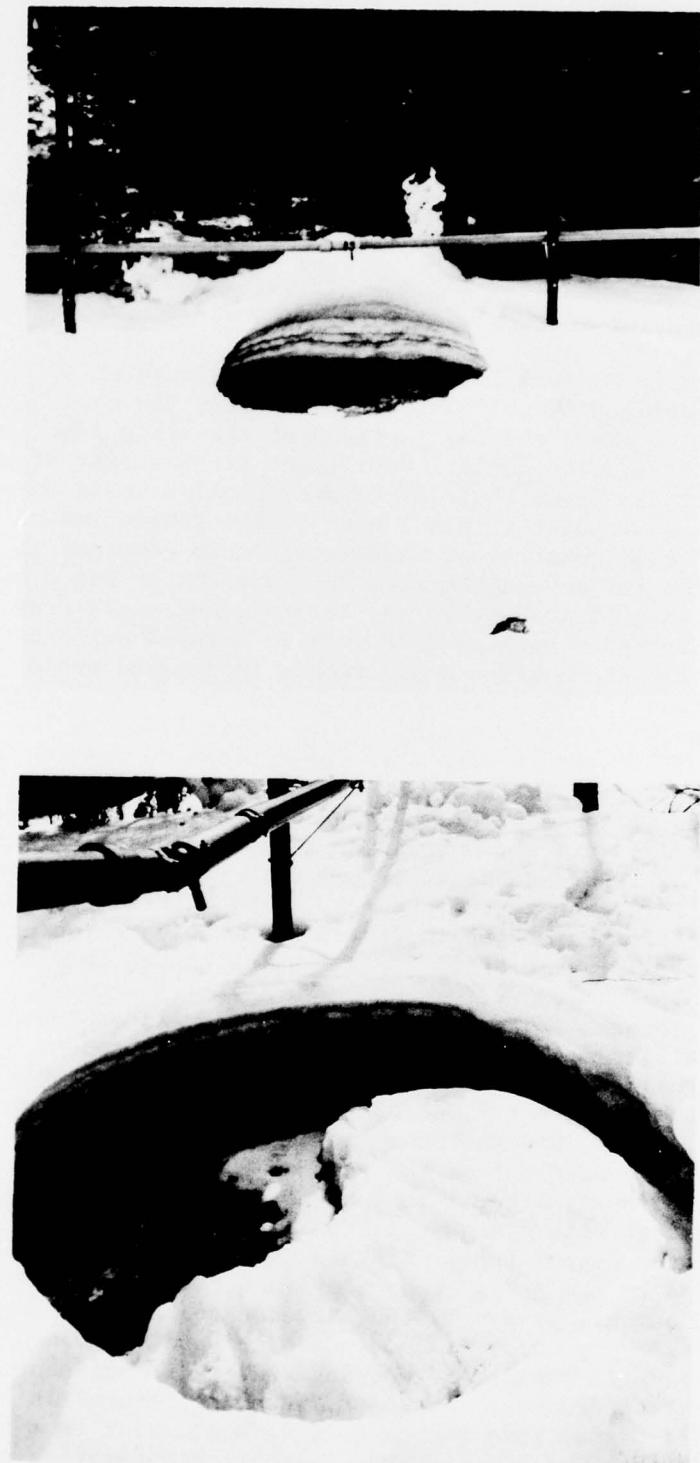
Figure 6. Downward-spraying nozzle.

Originally Parasol 1/2 E40 nozzles manufactured by Spraying Systems Co. were installed at the 66 low points along the spray laterals. Their purpose was to drain the low sections of the spray laterals after completion of a spray cycle. During the first winter of operation (1975-76) it was found that the Parasol nozzles would effectively drain most of the wastewater within 1 hour of the completion of a spray cycle. However, a small quantity of wastewater would continue to drip from these nozzles for several hours. This wastewater had a temperature of about 40°F when it was within the lateral, and would freeze at ambient air temperatures as high as 27°F when it dripped out. During the next spraying cycle the nozzles would remain frozen and would not spray. The frozen nozzles became a problem at the end of a spray cycle because there was no way for the wastewater to drain from the low points in the laterals. The laterals were then susceptible to damage caused by the progressive freezing of the wastewater left in them.

Because of these problems, the engineering firm of Dufresne-Henry of Springfield, Vermont, who had designed the system, conducted a special study (Dufresne-Henry 1976a). They evaluated several alternatives or partial solutions to the problem. Many alternatives were eliminated after an initial screening indicated they would be too expensive. Others were eliminated after field testing showed they did not alleviate the problem.

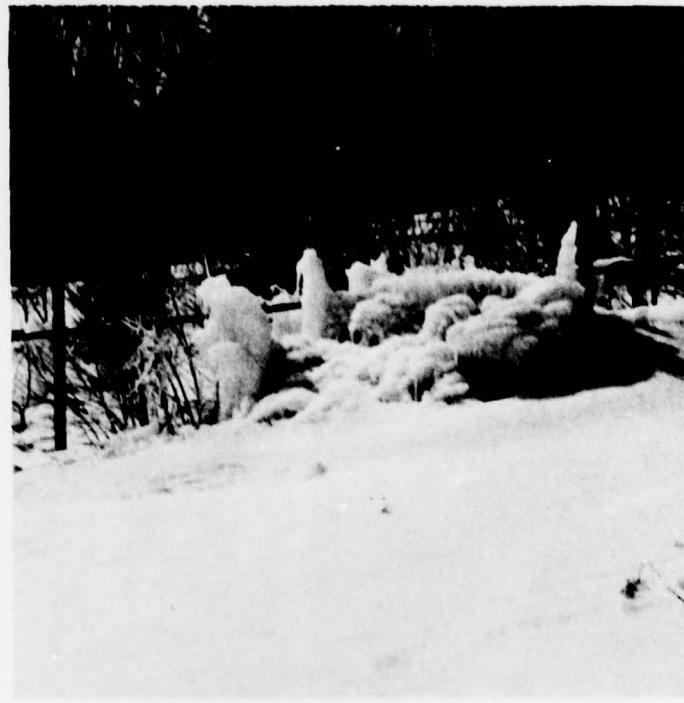
Figure 9. Snow and ice buildup near spray nozzle.

As spraying continued throughout the winter, large amounts of snow and ice formed under the spray laterals, particularly within the spray circle of the nozzles. During the winter of 1977-78 only laterals 5 through 9 were used. Typically, the operator would spray two of these laterals all day. On the next spray day he would spray two different laterals while he attempted to remove the ice that had built up during the previous day. Although the operator worked hard to remove the ice from the laterals a large amount of it did accumulate around the spray nozzles (Fig. 9). As these mounds continued to build, their weight actually caused sags in the spray laterals (Fig. 10). Because there was no way of draining them, these low points were very susceptible to freezing and bursting, or plugging of the lateral.

To minimize the buildup of ice and snow on the laterals, the operator, acting on the recommendations of Dufresne-Henry (Dufresne-Henry 1977), removed the spray nozzle from the lateral and placed it on top of a copper riser about 30-36 in. long. Angling the riser approximately 20-30 degrees from the vertical directed the spray away from the lateral. Figure 11 shows two of these experimental risers on spray laterals. The results were excellent and the operator intends to install these risers along the entire length of several laterals. Also, he plans to have all the risers on one lateral lean towards the west and those on the next lateral towards the east. Then he can select laterals where the spray will not be blown back on them by the wind.
